INVENTORY FORM FOR STATE HISTORIC SITES SURVEY

Springfield

Dodd Farm**2 LOCATION**

QA-439

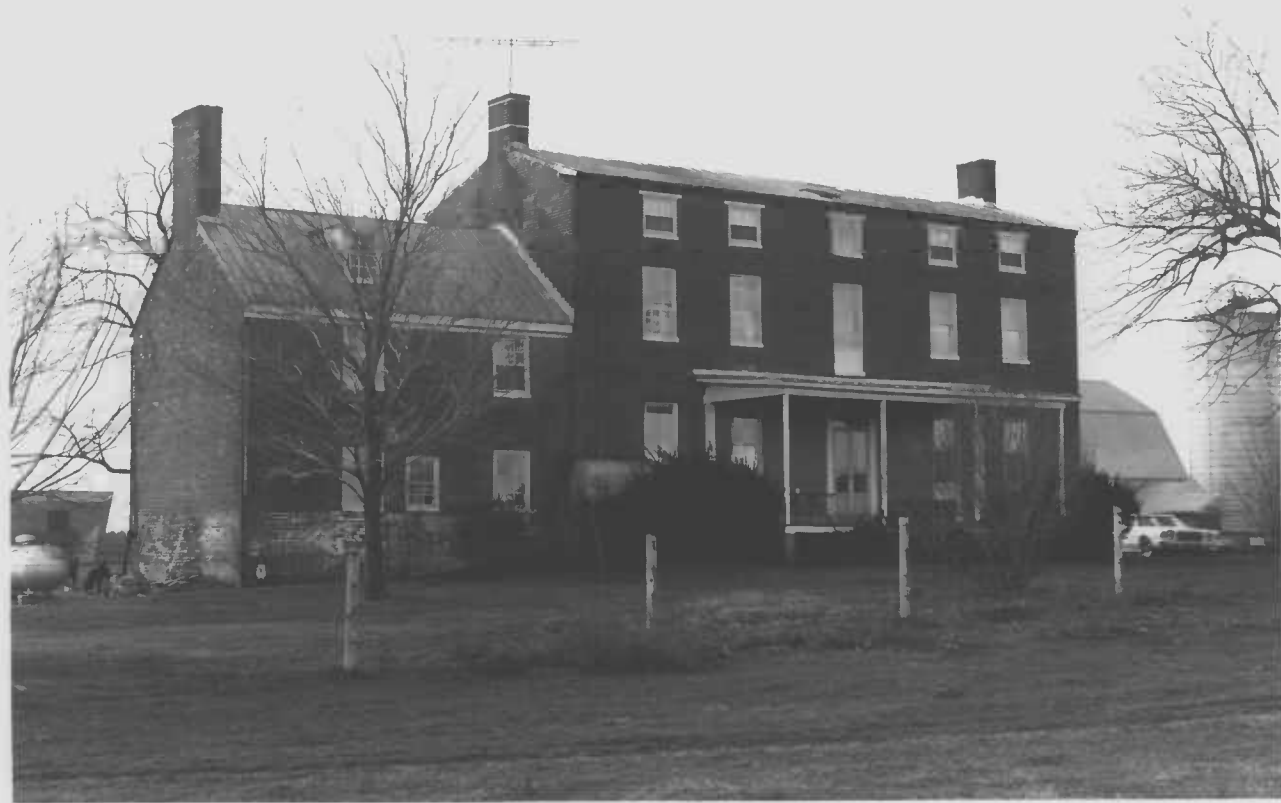
QA-439 Dodd Farm
 Queenstown vicinity
 Orlando Ridout V 1981
 North facade

The north facade is similar to the south facade, with double paneled doors in the center bay flanked by two 6/6 windows on each side. The window opening closest to the door on each side has been enlarged to form "jibb" doors. The lower six-light sash can thus be raised and paired panel doors opened to allow direct access onto the porch. There are five 6/6 windows ranged across the second story and five 3/3 windows across the added third story. The brickwork is Flemish bond above a molded water table and three-course bond foundation; a three-course Flemish bond belt course extends across this facade. The added third story is laid in seven-course bond with a corbeled brick cornice. A one story porch dating to
